Side Attics and Kneewalls- The Problems

Side Attics and Kneewalls -The Diagnostics

Side Attics and Kneewalls -The Solutions

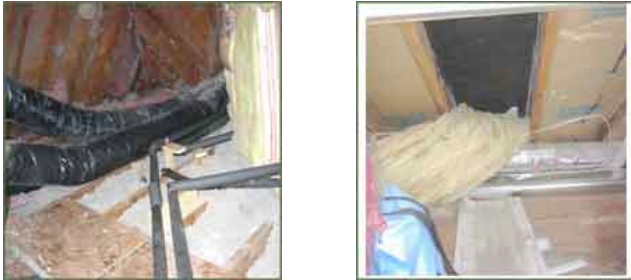
In many buildings there are areas and details that, by themselves, represent a substantial percentage of the buildings total heat loss. These same "key junctures" often have both thermal insulation failings and large air leakage areas that dominate whole house air exchange rates. Side attics are typical of these key juncture problem areas.

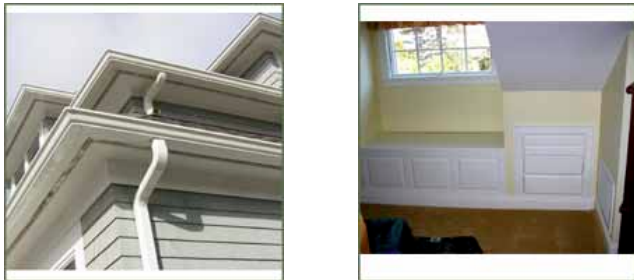
Side attics and other associated configurations include roof lines over side ells, bonus room attics, a mixed bag of kneewall shapes, bay roofs, shed roofs , flat roofs, plus the whole range of differing eaves assemblies.
